ON-SITE REPAIR, REFURBISHMENT AND HIGH VOLTAGE TESTS OF LARGE POWER TRANSFORMERS IN THE TRANSMISSION GRID

Th. ASCHWANDEN* A. SCHENK
BKW FMB Energy Ltd, Switzerland

1. INTRODUCTION

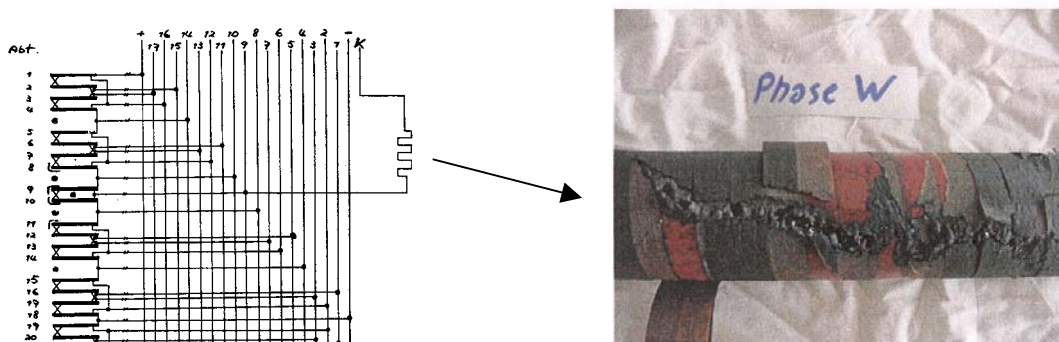
Figure 3: Damaged tie-in resistor of the regulating unit

The origin of the failure in the regulating transformer (group #32) was more difficult to find: a first inspection revealed no visible damage, however, the results of the dissolved gas-in-oil-analysis (DGA) indicated an internal electrical breakdown or flashover involving cellulose insulation material. Furthermore, resistance measurements indicated, that there might be a contact problem in the LTC-system. Therefore, this smaller unit (98 tons without oil) was transported to the transformer service facility of BKW in Wimmis (large hall with crane) for de-tanking and closer inspection. Here, the origin of the electrical failure was clearly identified in a AC voltage withstand test with 20% of the nominal voltage (no load), applied to 50 kV terminals of the de-tanked active part in air: the tie-in resistor of the tap selector (150 k Ω) of phase W was interrupted and caused an electrical breakdown (see Fig. 3). After the removal of the defective resistor the AC withstand test was successful. The rest of the active part, including the complicated regulating windings and the LCT-system, was found to be in an excellent condition. It was decided to carry out the necessary repair work and the high voltage tests at this BKW facility and to bring the repaired unit back to substation Bassecourt.

The replacement of all tie-in resistors and of all high voltage bushings (epoxy type with compound insulator) was the main repair activity at this unit. The design of the tie-in resistors was significantly improved: (a) better mechanical stability using an epoxy instead of ceramic carrier tube, (b) lower current density and lower thermal stress using a NiCr wire with larger diameter and class H insulation. As these resistors are permanently connected to the regulating winding, they are also exposed to significant electrical stress during transient over voltages. Therefore, all resistor elements were tested with 125 kV full and chopped lightning impulses.

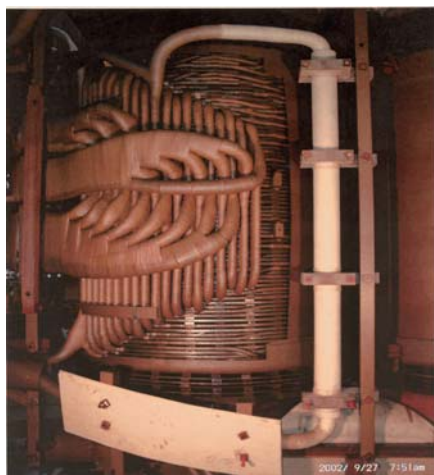
Figure 4: Replaced tie-in-resistor

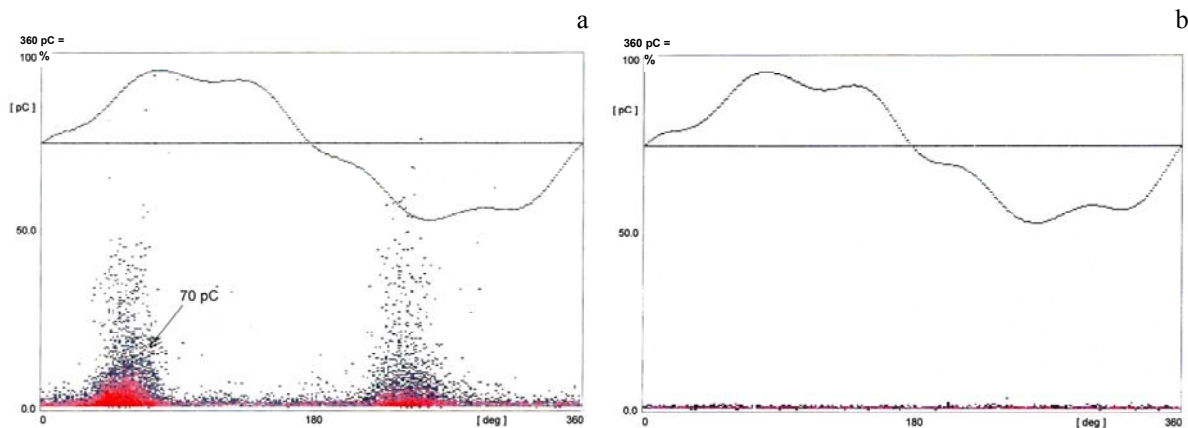
Performed test	Three phase excitation via 50 kV tertiary windings with mobile diesel generator-set up (60 Hz) and step up transformer PD-measurement at 110% U_n on 400 kV windings, 220 kV windings, neutral and tertiary windings.
Results	PD-activity was detected at the repaired 220 kV bushing at 100 % U_n (see Fig.6a), this PD-pattern is typical for bubbles in the insulating system caused by the local humidity [6]. After a further drying cycle this PD-activity extinguished (see Fig.6b). Due to the limited power of the generator-set the shape of the test voltage was strongly distorted by harmonics.

Figure 6: PD-activity at 220kV terminal phase V: (a) before and (b) after the last drying cycle
