ON-SITE REPAIR, REFURBISHMENT AND HIGH VOLTAGE TESTS OF LARGE POWER TRANSFORMERS IN THE TRANSMISSION GRID

Th. ASCHWANDEN* A. SCHENK
BKW FMB Energy Ltd, Switzerland

1. INTRODUCTION

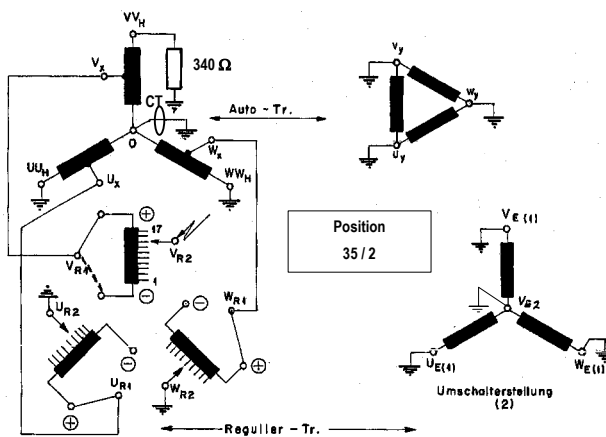
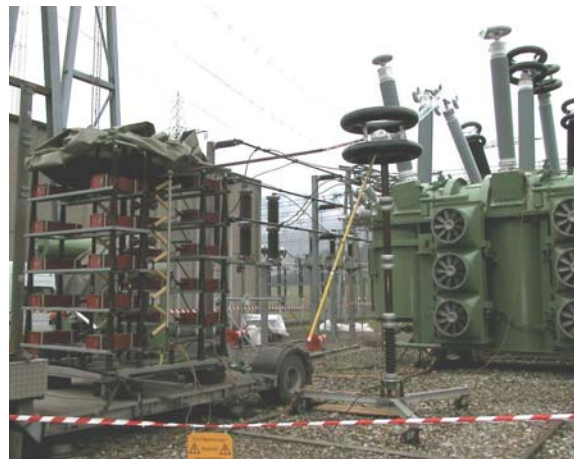
Figure 5: Setup for the lightning impulse test

Performed test	<p>Single phase lightning impulse test on the complete transformer group (220 kV terminals connected) using a mobile lightning impulse generator (see Fig.5)</p> <p>7 positive polarity impulses of 660 kV applied to 220 kV terminal of regulating unit</p> <p>7 negative polarity impulses of 660 kV applied to 220 kV terminal of regulating unit</p> <p>Amplitude of 660 kV corresponds to 120% surge arrester voltage at the 220 kV bus bar</p>
Results	<p>Comparison of the lightning impulse waveforms at 60% and 100 %.</p> <p>No breakdown or dielectric fault was detected during 14 lightning impulses applied to each phase</p>

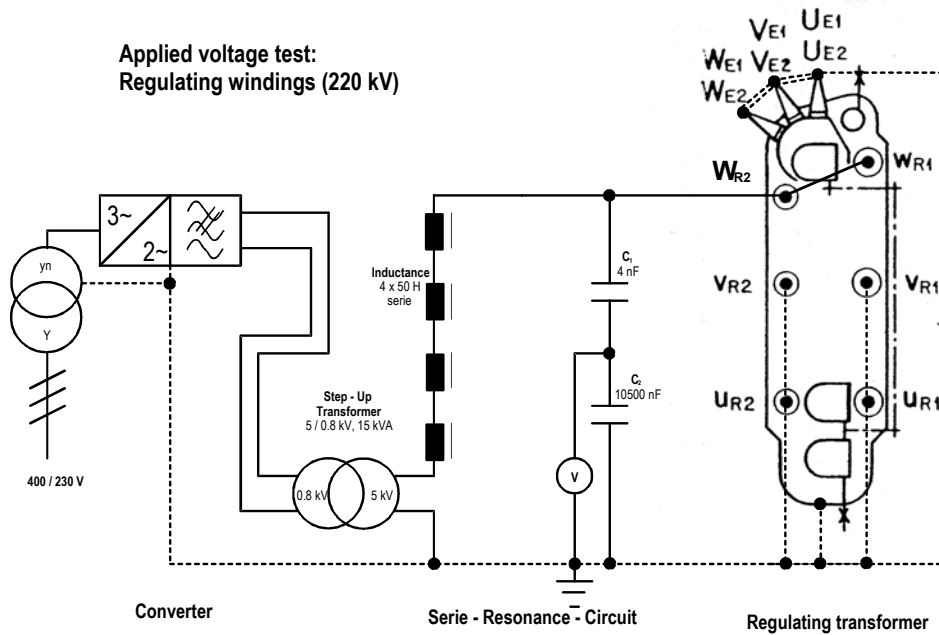
Figure 7: Circuit for the applied voltage test, example phase W

Performed test- on the regulating winding	Series resonance test circuit (resonance frequency between 110 and 119 Hz). Single phase test (see Fig.7). PD-measurement at 110 % U_n on 220kV windings and tertiary windings
Results	No PD-activity was detected. After alle modifications and repair work, the insulating system of all three phases is in an excellent condition.
Performed test on the tertiary winding	Series resonance test circuit (resonance frequency 94 Hz). All six bushings were connected together. PD-measurement at 110% U_n on tertiary windings via external coupling capacitance
Results	No PD-activity was detected. After all modifications and repair, the insulating system of the tertiary winding is in an excellent condition.
